# On the Weakening of Weathered Window Glass and Its Effect on Human Impact Resistance: Two Fatality Case Studies

## 2019 IIBEC Building Enclosure Symposium

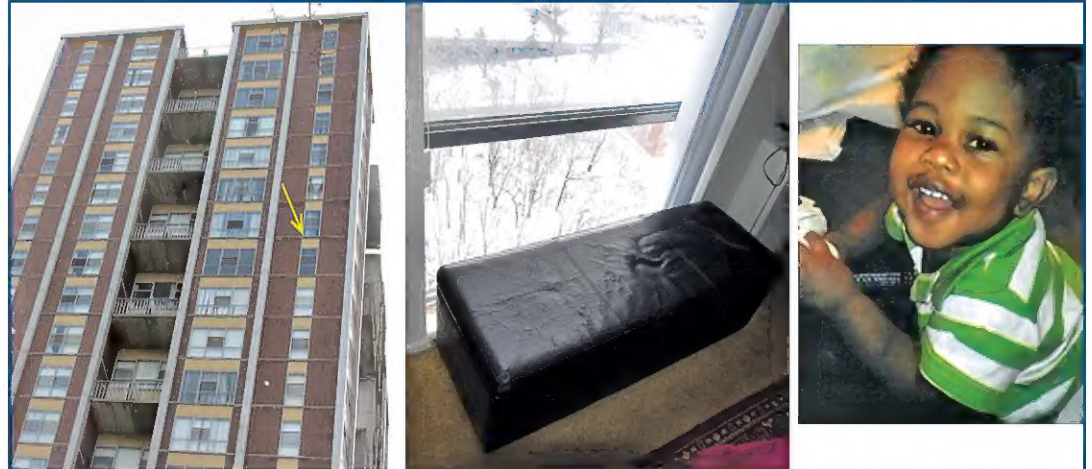
Alijah Glenn (Figure 1, right) was playing with his 3-year-old brother in their grandmother’s 17th-floor apartment (Figure 1, left) in Crystal Tower Apartments, East Cleveland, Ohio, on January 13, 2014. He placed himself in a narrow space between a nearby ottoman and a floor-level window (Figure 1, center). He broke through the monolithic non-safety glass and fell to his death. The only eyewitness was his brother. The family’s civil suit against the property settled prior to trial.

**Figure 1 – Left: Crystal Tower Apartments with arrow indicating incident window. Center: View from inside of incident window. Right: Alijah Glenn.**

In both cases, the glass that unexpectedly gave way was weathered, floor-level, monolithic non-safety glass. The glass at Crystal Tower was ½-in.-thick clear annealed glass that was 39 years old when the incident occurred. The glass at the W Hotel was ¾-in. bronze annealed glass that was 37 years old at the time of the incident (Figure 3).

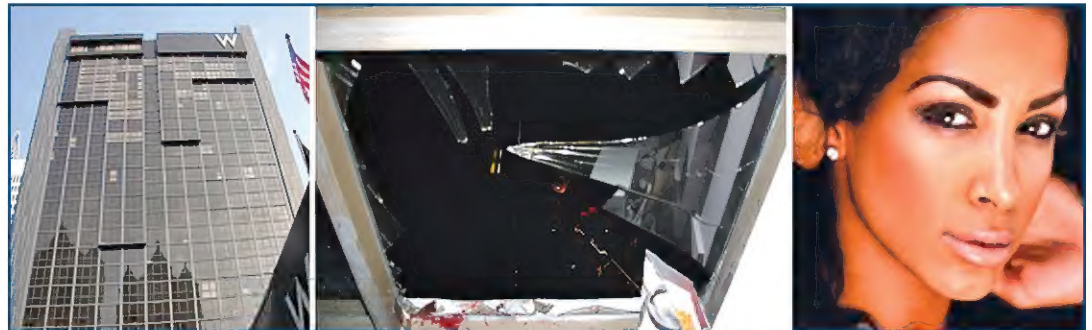
**Figure 2 – Left: The W Hotel, Atlanta. Center: Incident window. Right: LaShawna Threatt.**

model and mother of a daughter, was celebrating her 30th birthday on May 27, 2011, in the W Hotel in the Midtown neighborhood of Atlanta, GA (Figure 2, left). After dinner, a small group of friends came up to Threatt’s tenth-floor hotel room to continue the celebration. Threatt and her friend Cierra Williams were joking while crouching with their backs to the floor-level window, which was glazed with monolithic non-safety glass (Figure 2, center). They leaned against the glass, and it unexpectedly broke. Both women fell backward through the glass and fell to the sloped glass skylight eight floors below. Threatt died. Williams rolled down the skylight, fell off its edge, and dropped an additional distance to the pavement. She survived with permanent injuries. There

At the W Hotel, between 2008 and 2012, 102 glass lites had been replaced due to breakage. It was common that hotel guests were charged for the damage. The glass had been cap-sealed on the outside as a part of a prior renovation. On the inside, drive-in glazing gaskets were shrunk back significantly. During inspection of the incident hotel room, one of the other glass lites in the same incident room was found to be cracked.

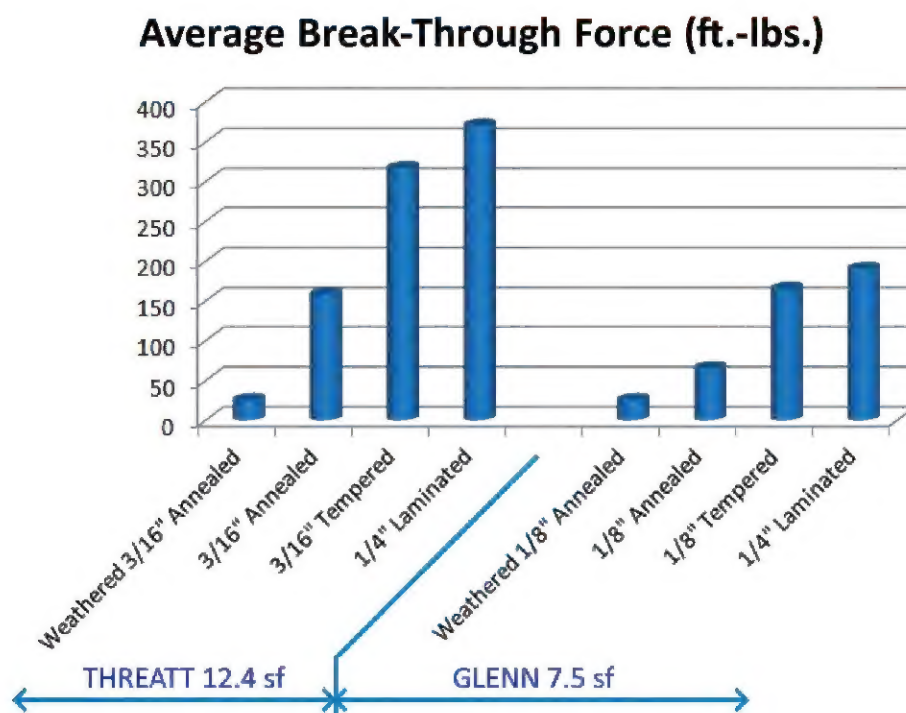
Figure 12 – Average break-through forces for each glass type, both incidents.

Test results for both incidents were consistent in demonstrating that weathered glass is severely degraded over time with regard to impact resistance. Further, the safety glasses (tempered and laminated) were found to be far superior against break-through when compared with annealed glass.

It is hoped that this information will sensitize building professionals to dangers posed by weathered glass in buildings, especially when it is non-safety glass at floor level. Armed with this knowledge, building inspectors should be better equipped to warn clients that dangerous conditions exist. Code writers are encouraged to strengthen language about requiring safety glass to be retrofitted in older buildings and disallowing the “grandfathering” of unsafe
